**Engineers Without Borders Erosion Control Projects  
Communities of Malingua Pamba, Tunguiche, and Guantugloma  
Cotopaxi Province, Ecuador**

**Ecuador Group, Denver Professional Chapter**

**June 2017 Monitoring Update with Photolog**

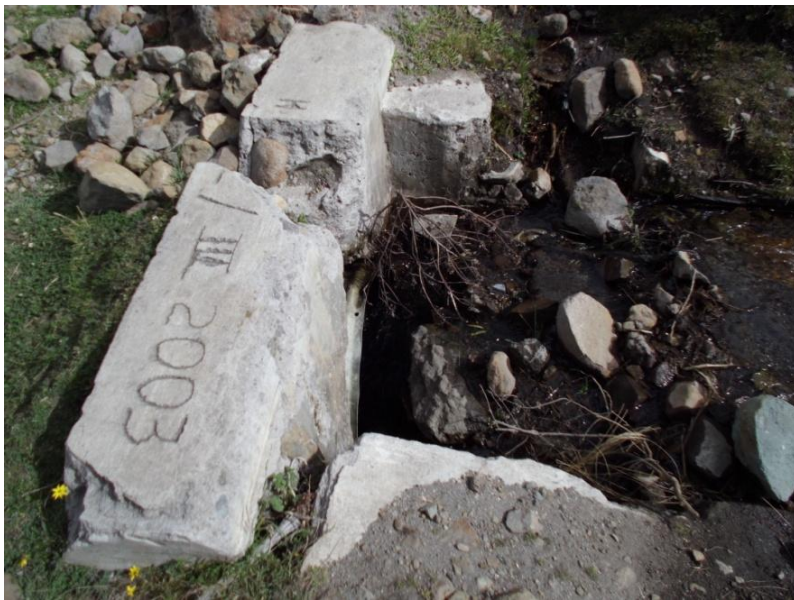
| Erosion Problem | Project Activities | Vegetation planting survival | Stability of culvert and road | New erosion features | Road closures due to erosion |
|---|---|---|---|---|---|
| Heavy rains of 2011 caused landslide on slopes above stream. Debris and a large boulder washed into culvert inlet. High flows over-topped inlet and road. | Native tree and shrub plug planting along 10 m of stream banks above the culvert. Removal of all material clogging inlet. | Very low due to grazing. | Structure and banks are stable<br>Culvert remains open, flows are not over-topping the road.<br>Functionality: 100% | None | None |

July 2012, pre-project. Note debris and large boulder from a landslide are clogging culvert inlet and forcing flows over the road.

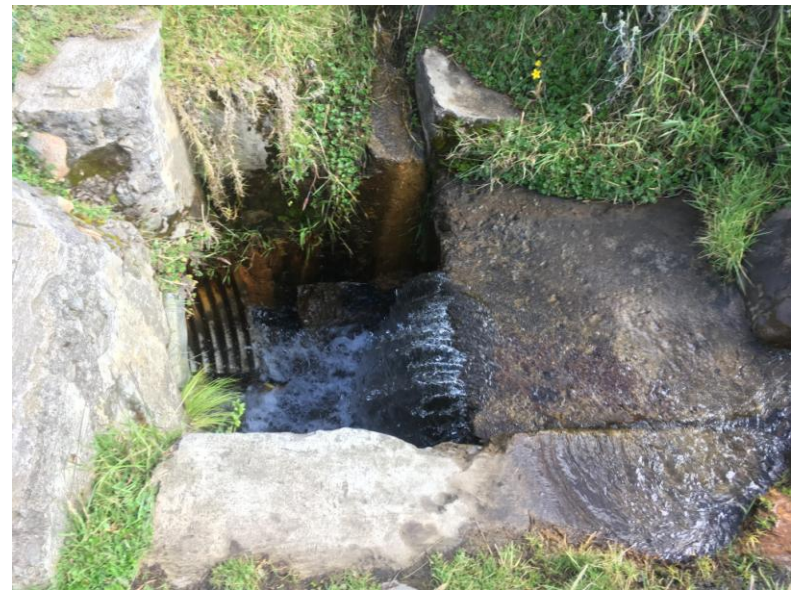
June 2017, 4 years following removal of boulder and debris. Water continues to flow freely through culvert; flows have not over-topped road.

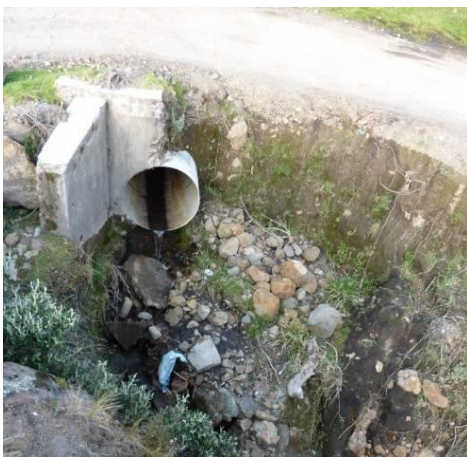
| Erosion Problem | Project Activities | Vegetation | Structures | Stability of road and culvert | New erosion features | Road closures due to erosion |
|--|---|--|--|---|---|---|
| Storm flows at the pipe outfall eroding the base of the road fill slope. | installation of boulder plunge pool at culvert outlet to dissipate energy of storm flows. | Excellent growth of volunteer chilca is stabilizing slope. | Boulder plunge pool effective, allowing chilca growth. | Functionality: 75-100% | None | None |

October 2012 view to north, pre-project. Note right side of wing wall is missing. Albert Kettner photo

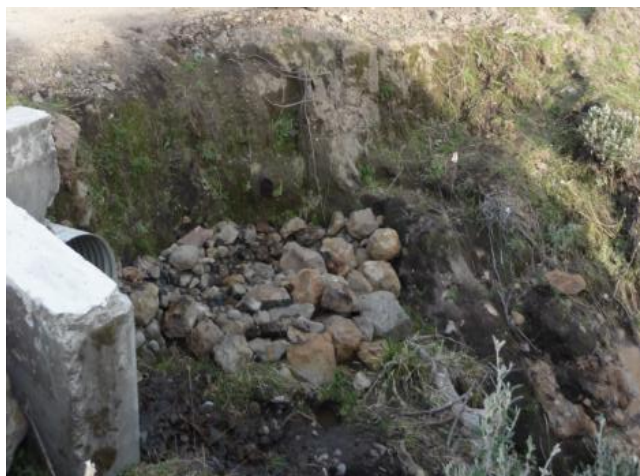
October 2012, view to north, post-project. Note boulder plunge pool constructed to protect roadside from further erosion. Albert Kettner photo

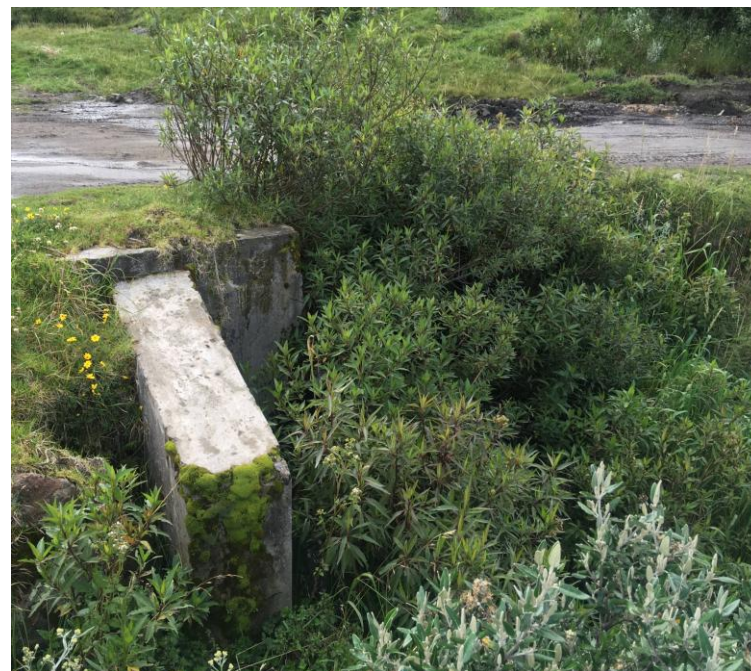
June 2017, view to north, 5 years post-project. Note that construction of the boulder plunge pool allowed stabilization of road slope and culvert outlet, thus allowing excellent growth of volunteers chilca which further stabilizes the infrastructure.

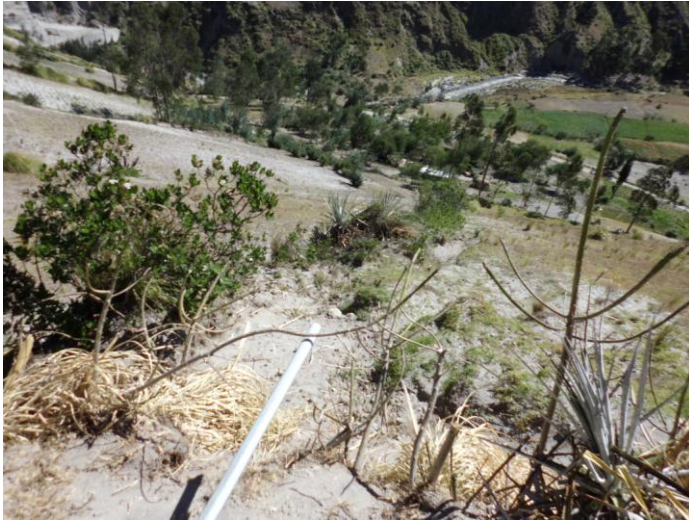
| Erosion Problem | Project Activities | Stability of irrigation tank | New erosion features |
|---|---|---|---|
| Gulleying from leaking pipe overflow pipe was threatening stability of irrigation system pressure break tank. | Installation of perforated PVC pipe to spread out tank overflows. | Improved | None |

July 2012, pre-implementation. Note pipe outlet from Tanque Tingo overflow pipe leakage is causing gulley erosion.

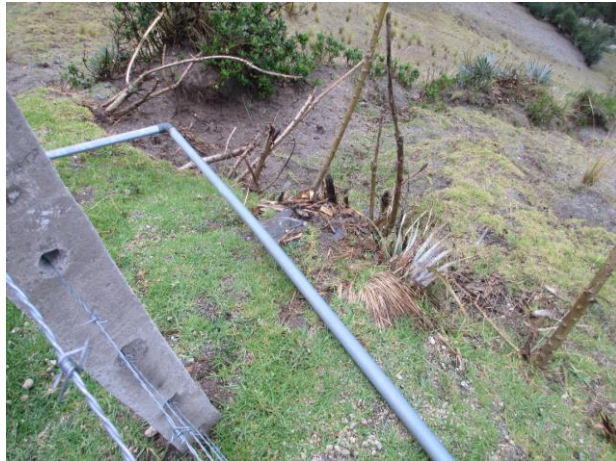
October 2013, 1 year post-implementation of perforated PVC pipe to spread out overflows from tank. Note village has fenced out animals.

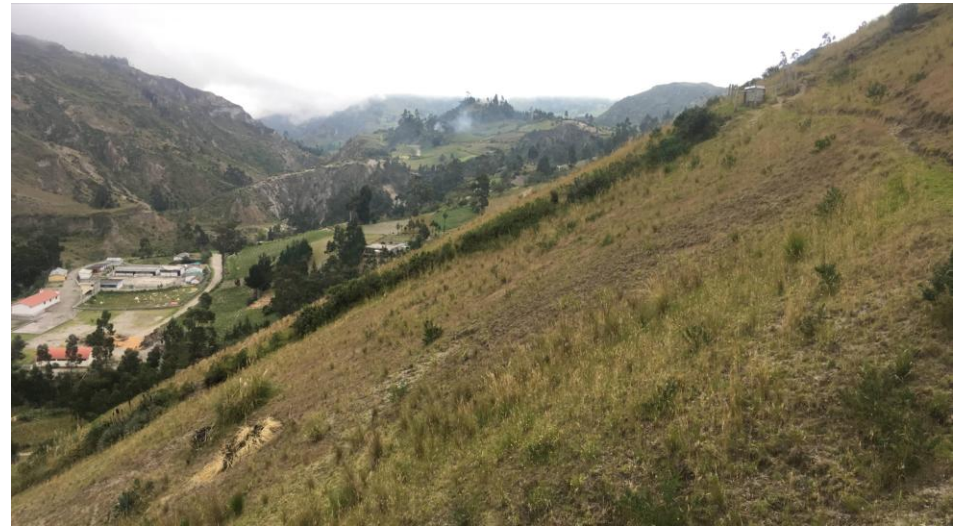
June 2017, view to north of Tanque Tingo and gulley from north gulley, about 60 m distance. Note development of shrubby vegetation in gulley below Tanque Tingo.

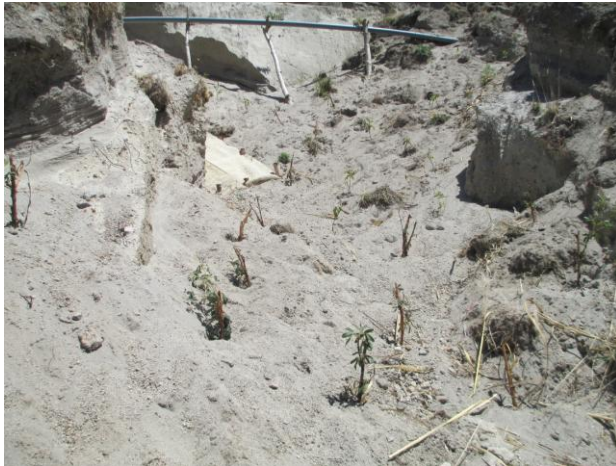
| <b>Erosion Problem</b> | <b>Project Activities</b> | <b>Vegetation planting survival</b> | <b>Stability of pipeline</b> | <b>New erosion features</b> |
|--|--|--|--|--|
| Gulleying caused by leaking irrigation pipe, then by pipe breakage | October 2012 - planting native trees and shrubs, installation of erosion matting | All plants washed out by pipe breakage. Pipe repaired in 2013; natural revegetation taking place | Irrigation pipeline and reconstructed trail appear stable. | Not known. Recommend replanting erosion gulley |

October 2012 post project. Note woody plantings in gulley below supported irrigation pipe.

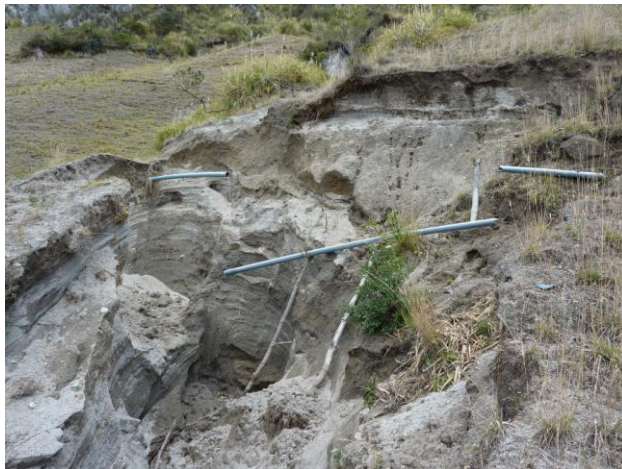
October 2013 view across top of gully, 1 year post-implementation. Slump occurred when the pipe burst 2 days before photo. All plantings appear to have washed out. Albert Kettner photo

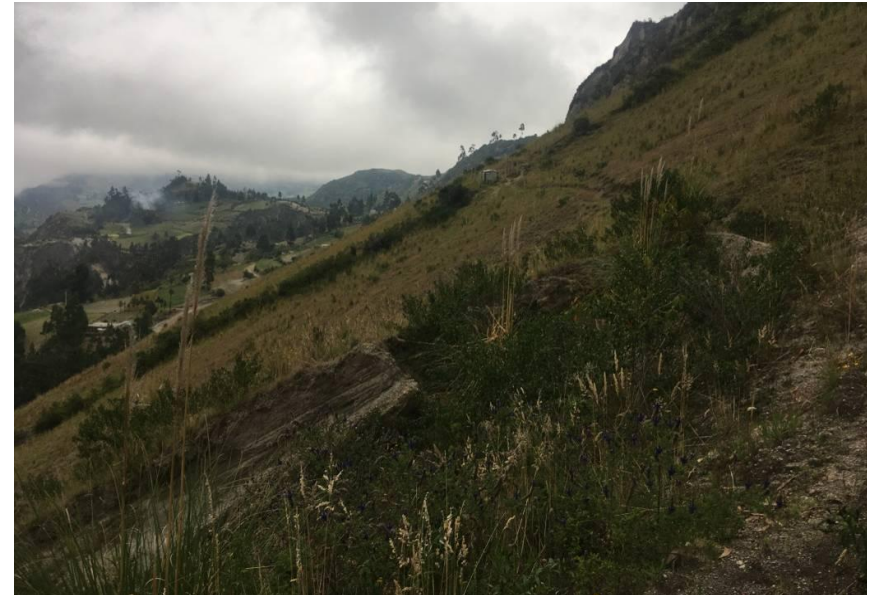
June 2017, 5 years post-implementation. Note that trail along irrigation pipeline has been reconstructed and woody vegetation is developing above gulley.

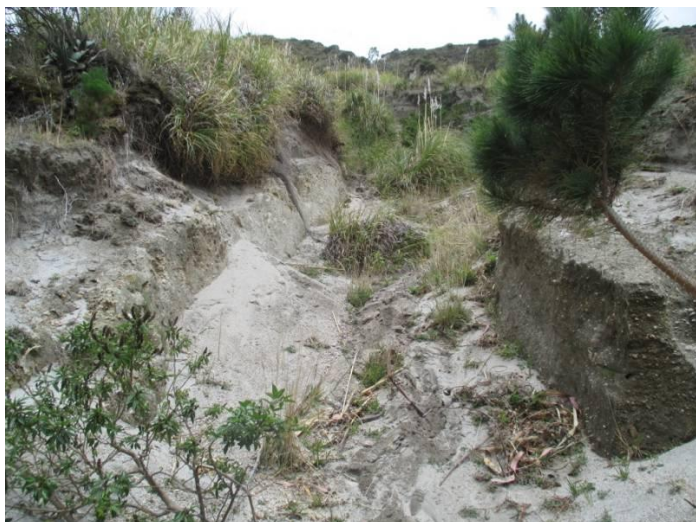
| <b>Erosion Problem</b> | <b>Project Activities</b> | <b>Vegetation planting survival</b> | <b>Stability of pipeline and gulley</b> | <b>New erosion features</b> |
|---|--|---|---|---|
| Gulleying caused by Irrigation pipe leakage . | Installation of live post and wicker grade control: lechero poles, sigsig grass hedges plus mats with woody plantings. | Low, but sufficient to greatly reduce erosion and promote volunteer species. Wicker weirs are effectively holding sediment. | Functionality: 50-75% | Gulleying evident, pipeline at top of gulley is undercut. |

October 2013, pre-implementation, view up gully. Note sparse vegetation in gulley and unstable soils. Jen Walsh photo.

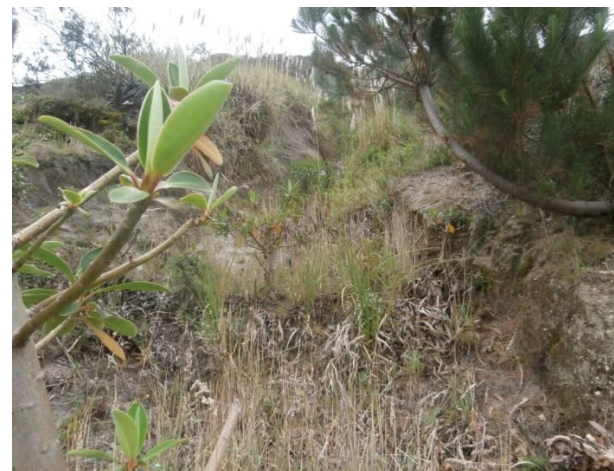
March 2015, 1.5 years post-implementation. Note that wicker weir has held in place, vegetation cover increased. Same overhanging pine branch as 2013 photos.

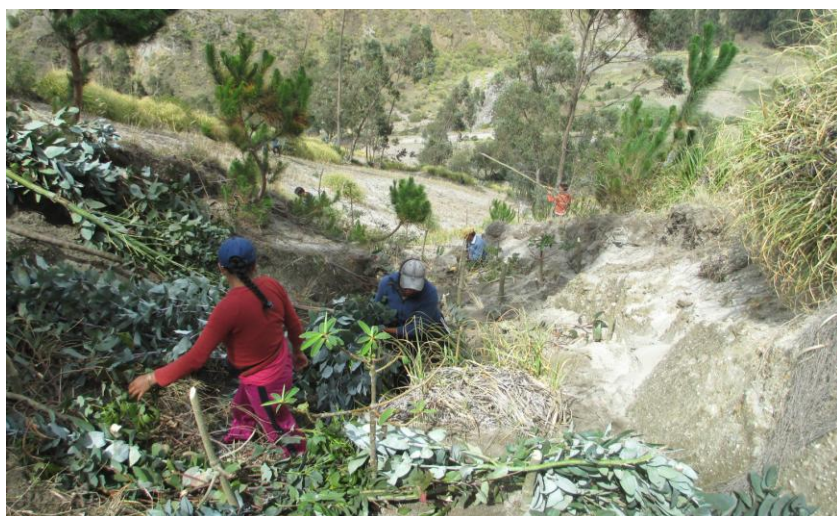
October 2013, view down gully of construction of living wicker weirs.

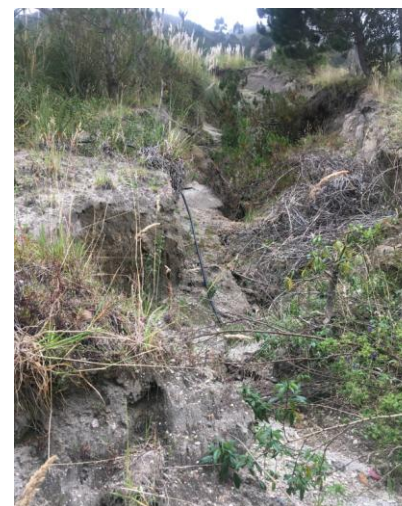
June 2017, 3.5 years post-implementation. Note both new gulleying from possible pipe problems / heavy rains and survival of stabilizing vegetation.

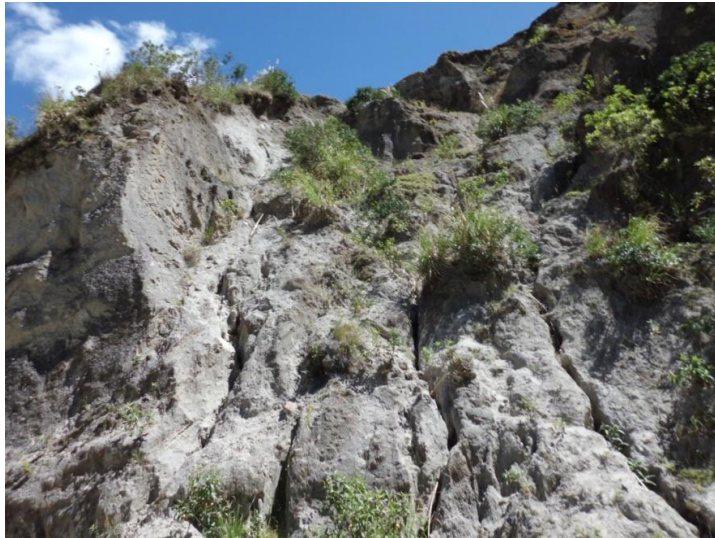
| Erosion Problem | Project Activities | Vegetation planting survival | Slope stability | New erosion features | Road closures due to erosion |
|---|--|--|---|---|---|
| Unstable volcanic subsoils slumping during heavy rains causing road closures. | Native tree and shrub plantings, sigsig grass hedges on contour. | Low, but sufficient to greatly reduce erosion and promote volunteer species. Grass hedges effective. | Functionality: 75-100% | None | None |

July 2012, pre-project. Note deep rilling, sparse vegetation following 2011 slumping and road closures.

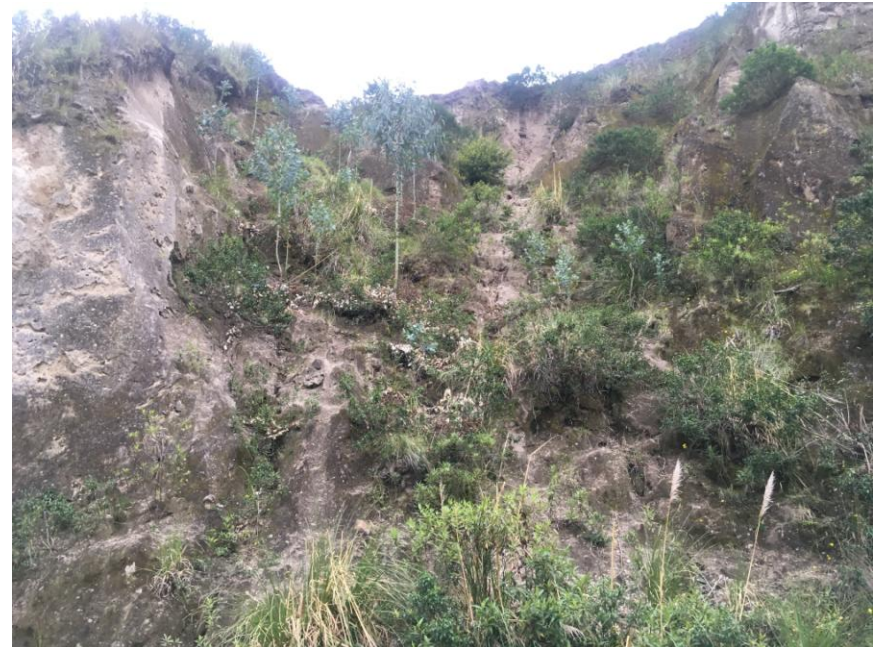
June 2017, 4.5 years post-project. Note greatly decreased rilling and increased vegetation cover by plantings and volunteer native species and invasive eucalyptus.

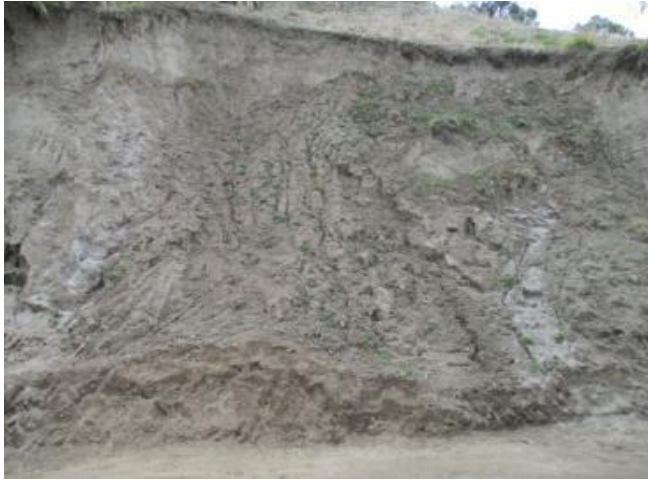
| Erosion Problem | Project Activities | Structures | Vegetation planting survival | Slope stability | New erosion features | Road closures due to erosion |
|---|--|---|--|---|---|---|
| Slumping during heavy rains causing road closures | Installation of erosion mats, woody plantings, grass hedges, tree pole plantings to block animal access. Construction of boulder toe wall. | Boulder retaining wall effectively held soils in place while plant roots developed. | Low, but sufficient to greatly reduce erosion and promote volunteer species. Grass hedges grew well. | Functionality: 75-100% | None | None |

October 2012 Pre-project. Note almost barren slope. Slump debris at toe along roadway.

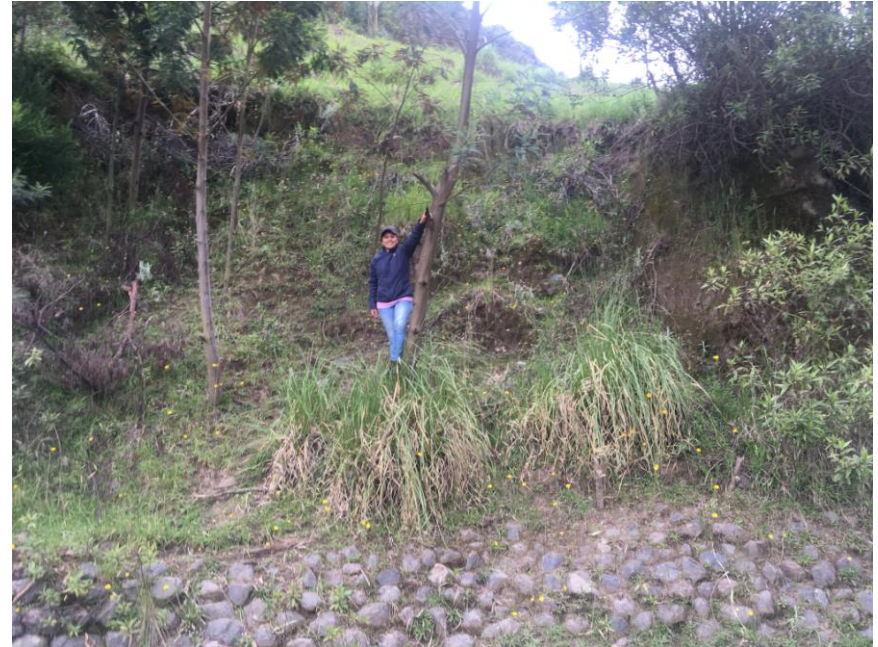
June 2017, 5 years post-construction. Note very good growth of native acacia trees, sigsig grass hedge, good vegetation cover. Retaining wall remains in place, stabilized by volunteer plantings inbetween boulders.

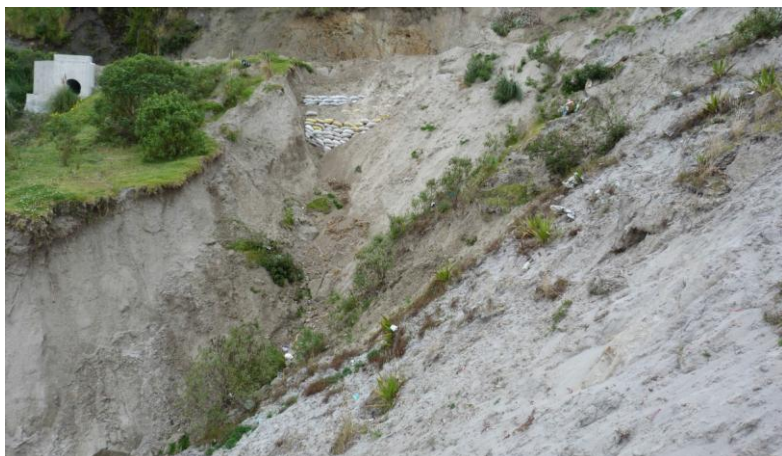
| Erosion Problem | Project Activities | Vegetation planting survival | Structures | Slope Stability | New erosion features | Road closures due to erosion |
|--|--|--|--|---|---|---|
| Steep, unstable slope below road. Sand bags are shoring up area of water draining from road and cut slope. | Installation of erosion mats with native woody plantings, grass hedges along contours. Construction of boulder step pools in sandbag area. | Low, but sufficient survivorship to stabilize slope. Grass hedges grew well. Some eucalyptus invasion. | Step pools effective in stabilizing slope while plant roots developed. | Functionality: 75-100% | None | None |

July 2011, assessment trip, view to NE. Note active erosion and placement of sand bags below the road, white road culvert on left. Will Mahoney photo

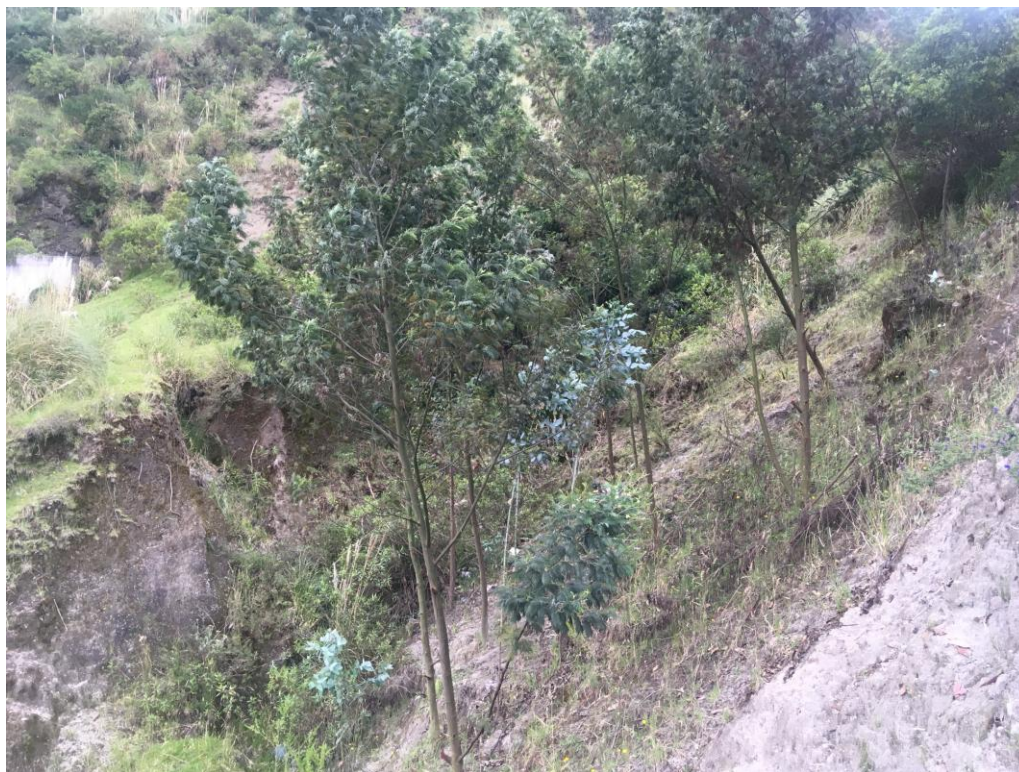
June 2017, 4.5 years post-implementation, view to NE. White road culvert shown in 2011 photo is at left. Note very good growth of trees, much increased vegetation cover contributing to increased soil stability, some volunteer invasive eucalyptus. Enma Sacatoro photo

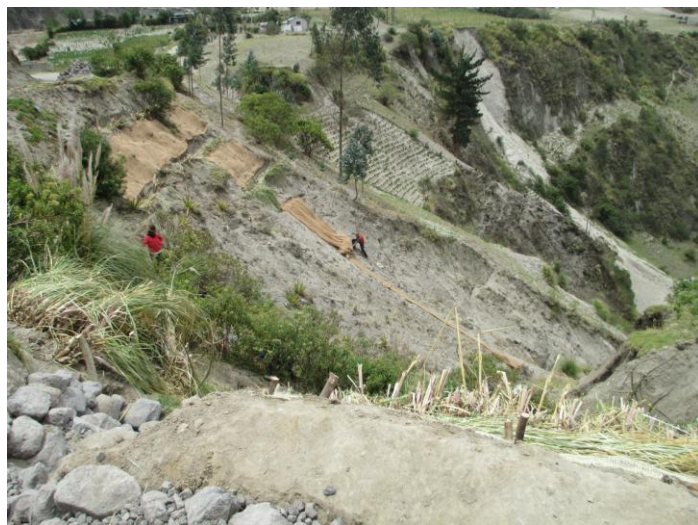
October 2012, Project Construction, view to SW. Erosion mats and sigsig hedges in center; boulder step pools at lower left.

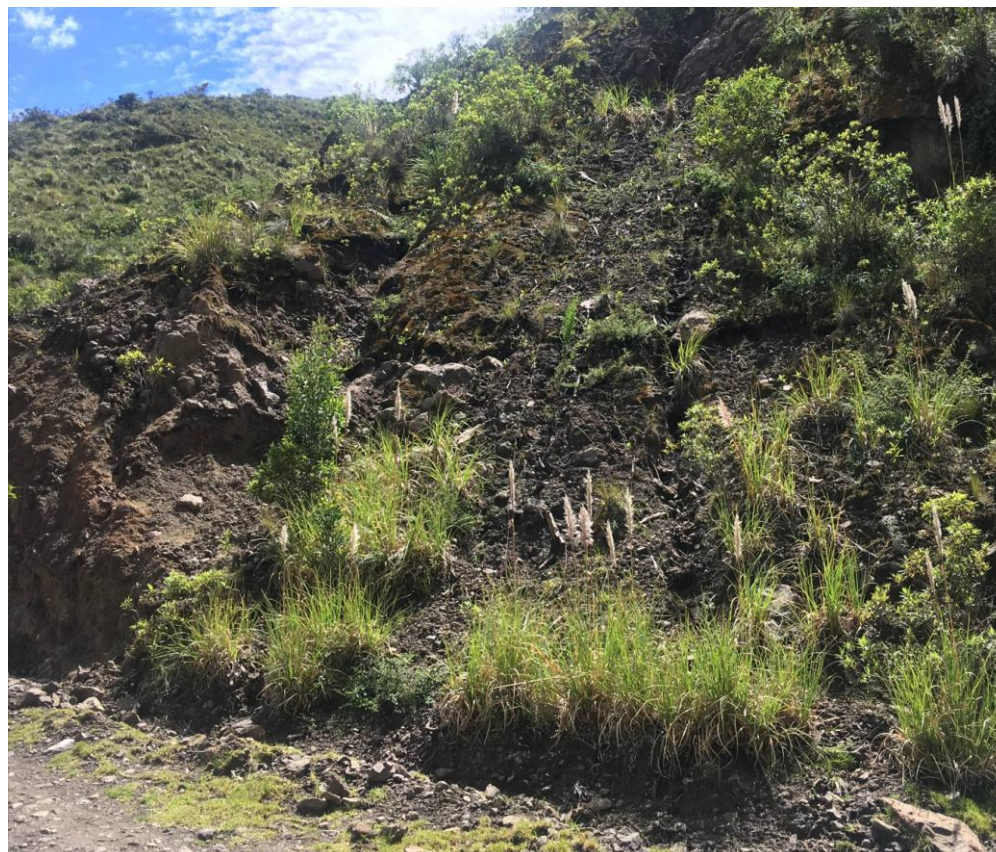
| Erosion Problem | Project Activities | Vegetation planting survival | Slope stability | New erosion features | Road closures due to erosion |
|---|---|---|---|---|---|
| Slumping road cut causing road closures | Installation of erosion mats with woody plantings, grass hedges along contours. | Low for woody plantings, but sufficient to greatly reduce erosion and promote volunteer species. Grass hedges are vigorous, not palatable to sheep. | Functionality: 75-100% | None | None |

June 2017, 3.5 years post-implementation. Note development of shrubby plantings and volunteer plants, good growth of sigsig grass hedges.

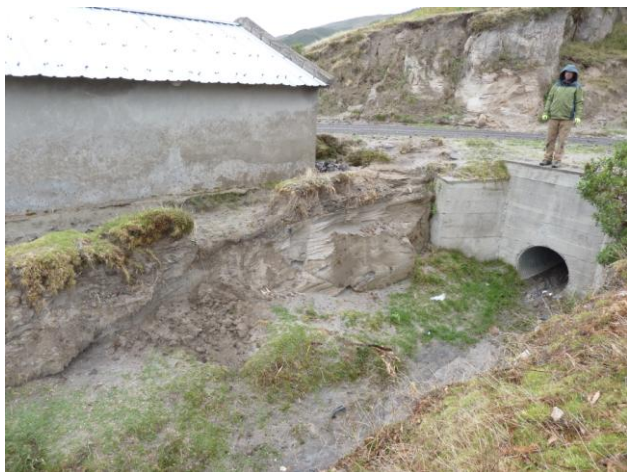
| Erosion Problem | Project Activities | Vegetation planting survival | New erosion features | Road closures due to erosion |
|---|---|---|--|---|
| Culver storm water discharge threatening adjacent house | Installed woody plantings and erosion mats along slopes of channel below culvert outlet. Placed log and boulders at toe of side slopes to stabilize soils during plant establishment. | Low, but sufficient survivorship to stabilize sides of channel, especially with Invasion of Scotch broom. | Upper channel is stable, as well as sides of lower channel. Grading of slope and removal of soil above culvert inlet have changed drainage pattern. Culvert is nearly filled with sediment. Functionality: 75-100% | None<br>Owner of house is building 2 <sup>nd</sup> house adjacent to channel. |

October 2012, pre-project, view across drainage below culvert. Note active erosion of drainage bank adjacent to house. A Kettner photo

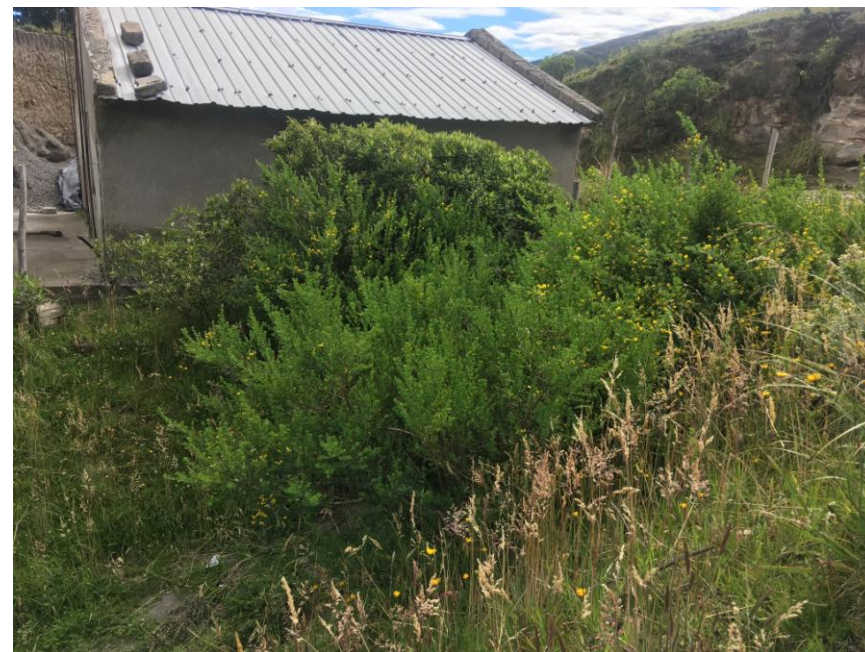
June 2017, 4.5 years post-implementation. Note vigorous vegetation growth, especially of non-native Scotch broom, has stabilized channel sides, house is intact.

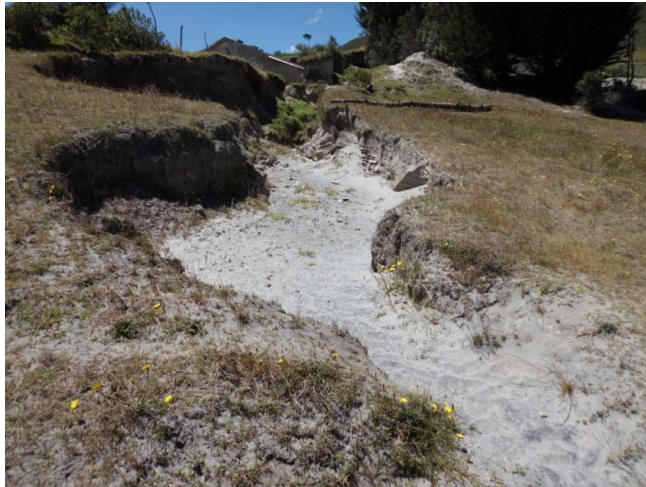
| Erosion Problem | Project Activities | Vegetation planting survival | Structures | Channel stability | New erosion features |
|--|--|---|---|--|--|
| Downcutting from culvert storm water discharge | Installed woody plantings along banks. Constructed cross-vanes, boulder plunge pools, infiltration trench at channel terminus. | Low, but sufficient survivorship to stabilize sides of channel. | Plunge pools intact, very effective. Very little remains of cross-vanes except for largest structure at low end of channel. Fate of cross-vanes is unclear. | Functionality: 75-100% above cross-vane, 50-75% below cross-vane. Changed conditions due to slope cutting above culvert. | Sides of lower channel are stable. In-channel downcutting below remaining cross-vane. Natural gully below the channel could be at risk during very high flows. |

July 2012, pre-project, view up drainage. Note actively eroding channel walls and extensive sand deposition.

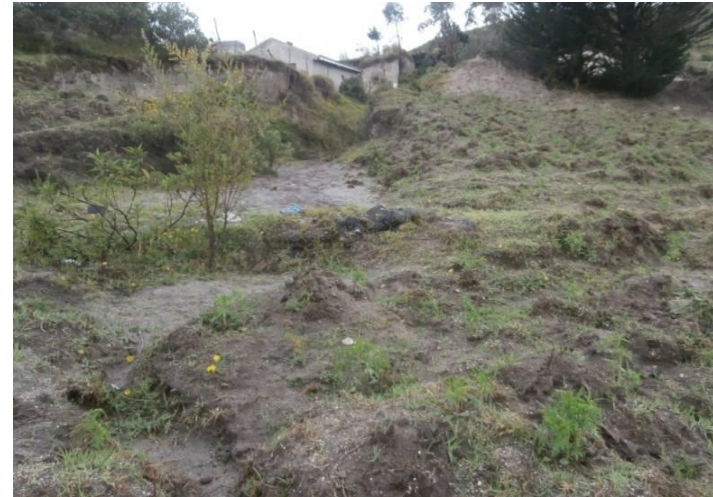
March 2015, 2.5 years post-implementation. Note increased plant growth, probably due to cessation of grazing and possibly reduction of scouring flows.

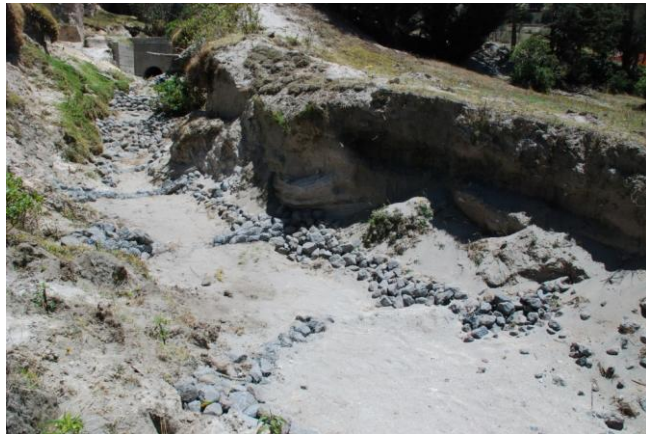
October 2012, post-implementation. Note 3 of the 4 cross-vanes in lower channel, 2 step pools above in upper channel.  
Matt Barbian photo

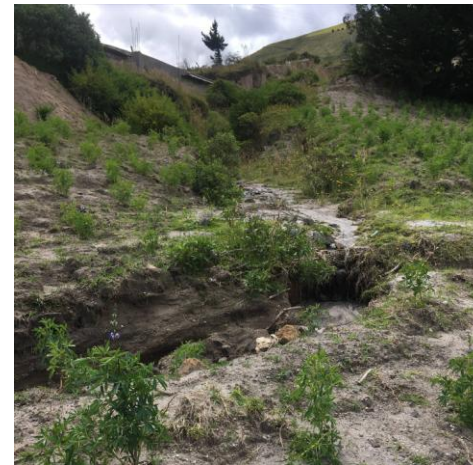
June 2017, 4.5 years post-implementation. Note good shrub growth at channel sides, downcutting in potato field occurring below remaining cross-vane.

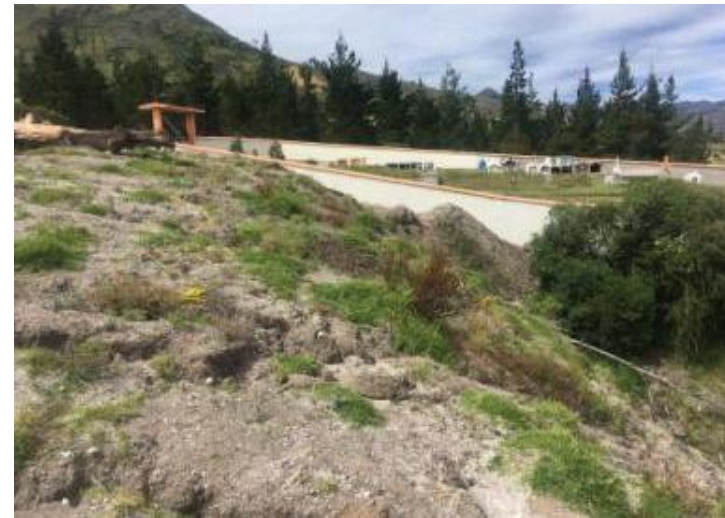
June 2017, low planting survivorship, but grasses are beginning to stabilize slope.
